Application of the electrical tomography technique in the design of a soil-nailing reinforcement for a slope in karstic limestone and sandy colluvial

ABSTRACT: This case studies the implementation of a large slope in the newly built A8 motorway, located close to Buelna (Asturias), where a mesh of electrical tomography profiles has been used to detect the presence of karstified limestone ridges under sandy colluvium. The results collected were used to design a steeper slope and to undertake the necessary improvements of the colluvial area by using soil-nailing techniques. This reinforcement proves to be a more suitable solution, when necessary, than other more expensive options.

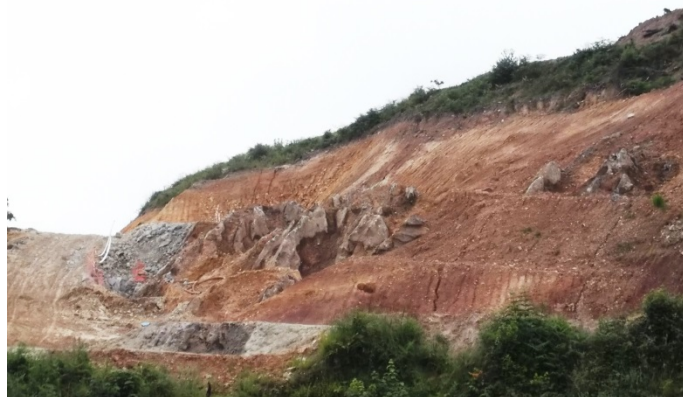
Figure 1. Slope before reinforcement action. Some limestone ridges are visible outcropping at the bottom of the slope.

Through a number of boreholes and some nearby outcrops, it was known that beneath the colluvium there was limestone bedrock. However, the topography of that bedrock was unknown. The limestones in this area are well karstified, and have an irregular and discontinuous distribution that is filled by colluvial material. Yet, due to the high gradient of the slope that would have required the creation of complicated road access, it was difficult to investigate the position of bedrock from boreholes (Fig. 1).

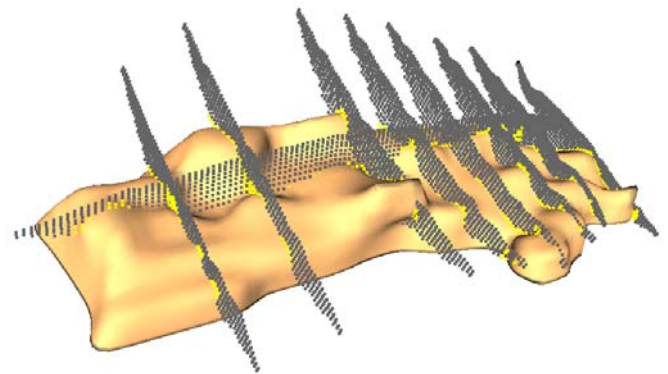
Figure 5. Design of soil nailing based on the occurrence of limestone detected by Electrical Tomography.

Based on the interpretation of electrical tomography, a 3D model showing the irregular topography of the contact between the colluvium and limestone bedrock was also developed (Fig.5).

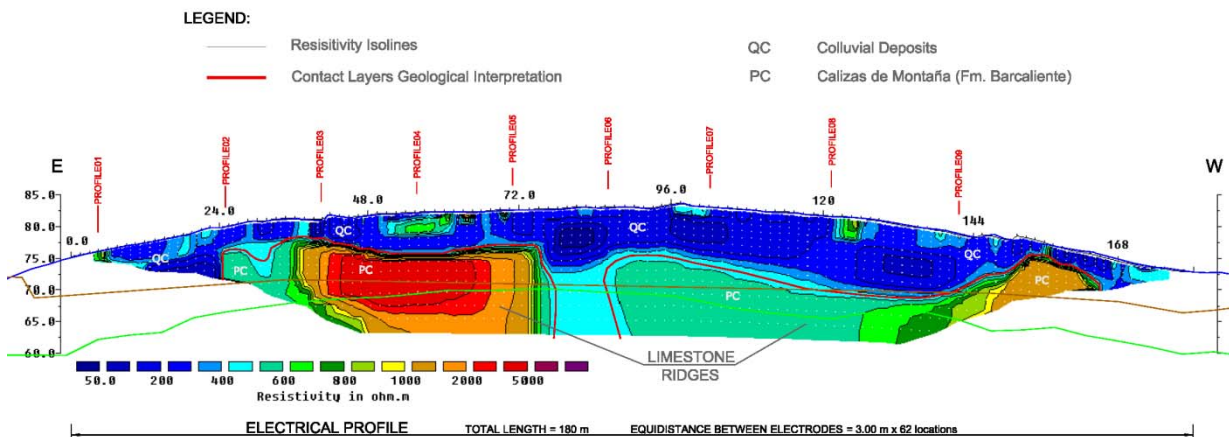
Figure 4. Longitudinal profile interpretation on the current hillside and overprinted the future slope.

In the longitudinal profile (Fig.04) the irregular morphology of limestone bedrock can be observed, and two limestone ridges are detected spaced 10 m.

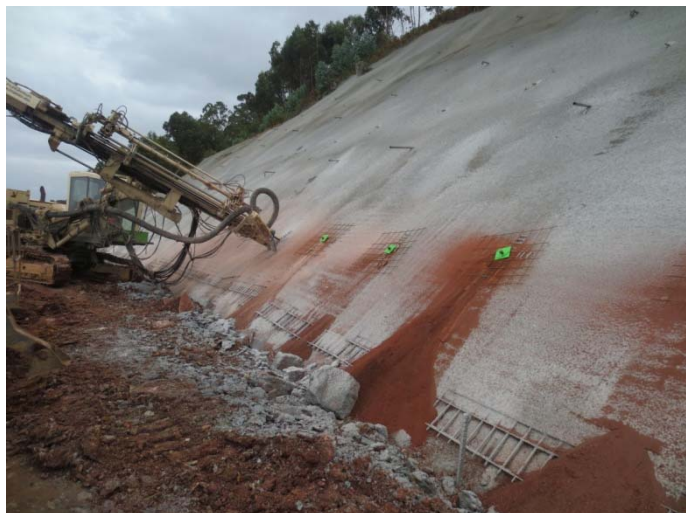
Figure 6. Design of soil nailing based on the occurrence of limestone detected by Electrical Tomography.

The new design of the slope reinforcement consisting of (Fig. 6):

- Benches of 1.60 m height
- Grid of soil nailing with $\varnothing 25$ steel bars
- Horizontal drains and weep holes

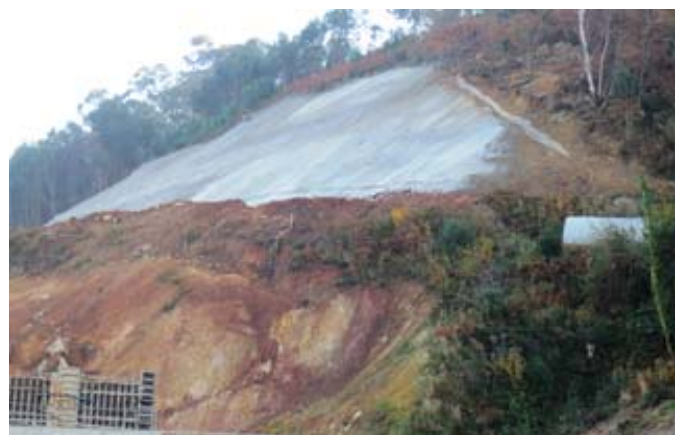
Figure 7. Slope picture after placing soil-nailing in the top half.

The fundamental concept of soil nailing is to reinforce the ground by installing passive anchorage bars to which cement grout is injected at a slope or excavation, as a constructive process from the top to the lowest parts of the slope. This process avoids the decompression; since the slope decreases the bars are taking charge (Fig. 7).
